**US Army Corps
of Engineers®**

Demonstration Erosion Control Project Monitoring Program

Fiscal Year 1995 Report

March 2000

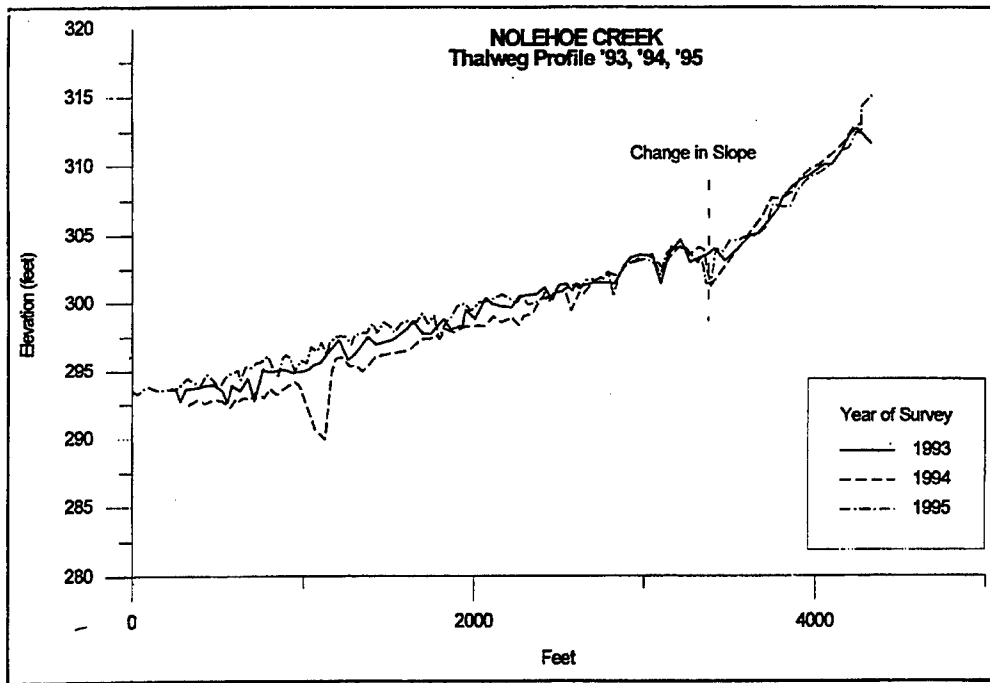
Figure 39. Thalweg profiles for Nolehoe Creek, site #7

The thalweg profile indicates that the lower Segment 1 has aggraded slightly and that the upper portion of the segment has changed little (Figure 39). Segment 1 has been classified as CEM 4, Segment 2 is classified as CEM 2. Segment 2, upstream of the break in slope, is very steep and dynamic. Segment 2 concentration is more than 4 times Segment 1, and continuing urbanization will accelerate the upstream degradation, which will place the upstream box culverts at risk. Channelization of Segment 2 to include grade control, and similar treatment for the tributary entering from the north at the break in slope should be considered. Property owner permission may be a major impediment to any future work.

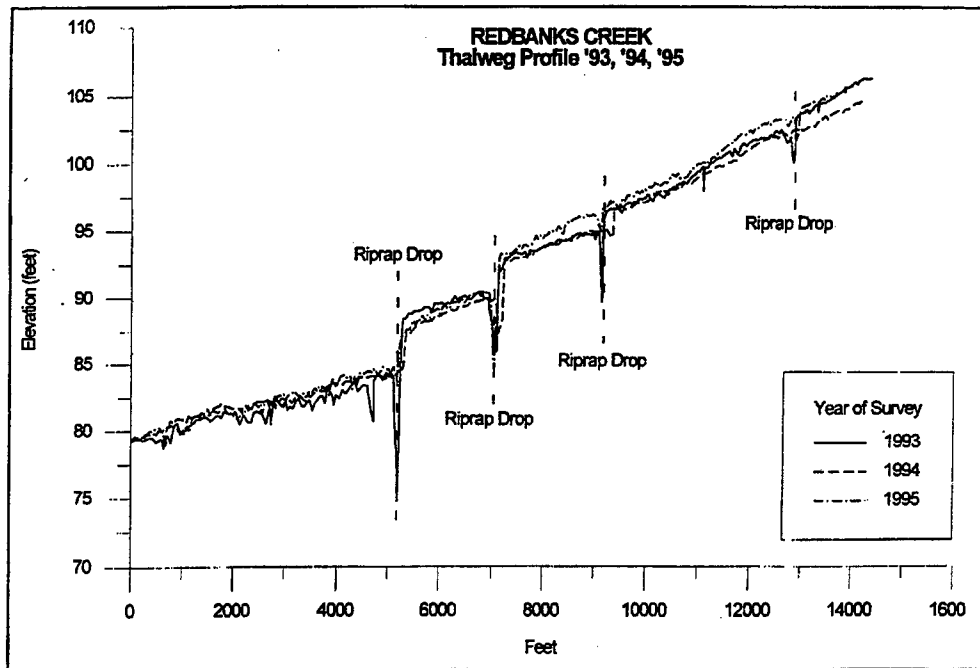
Figure 45. Thalweg profiles for Redbanks Creek, site #9

Bank stability increases in the upstream direction. Using the zero friction angle assumption, 100% of the banks are at risk at the downstream Segment 1 and only 8% of the banks are unstable in Segment 5. This improvement in stability is consistent with the use of serial grade control structures to reduce bank height. Consideration should be given to refurbishing the existing Chevron weirs, perhaps by rebuilding and extending the structure length. Consideration should be given to additional structures downstream. The BURBANK results indicate that the existing weirs are important in maintaining bank stability.

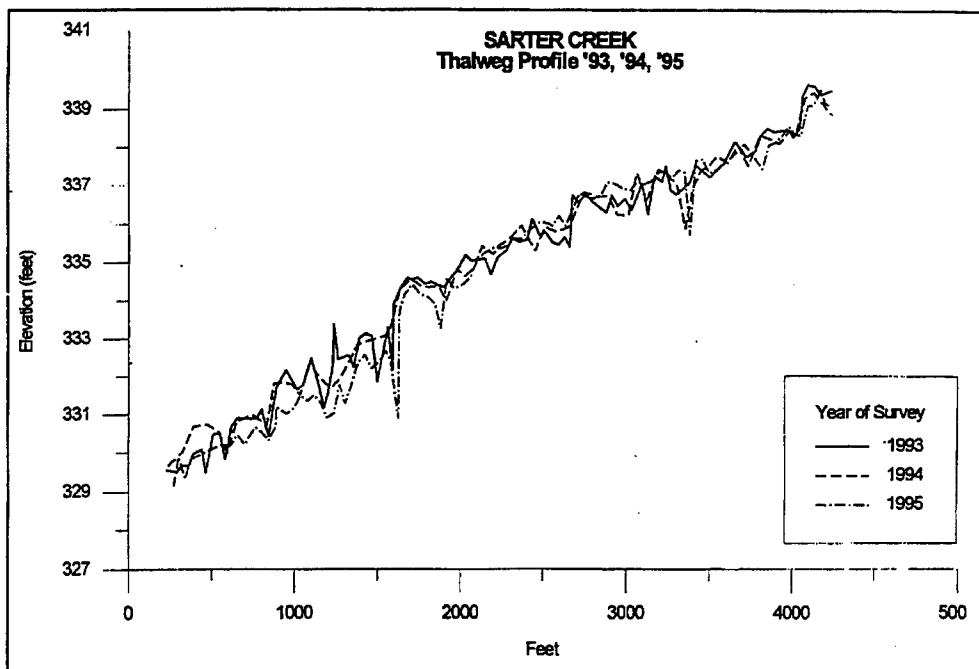
Figure 47. Thalweg profiles for Sarter Creek, site #15

The 1995 profile indicates continuing incision. Field inspection in November, 1995 confirmed several headcuts, and that numerous beaver dams are playing an important role in maintaining the stability of the channel. The channel ranges from a CEM 4 at the downstream extent to CEM 2 upstream, and has been given a CEM 3 designation overall. Riprap grade control should be considered for the site.

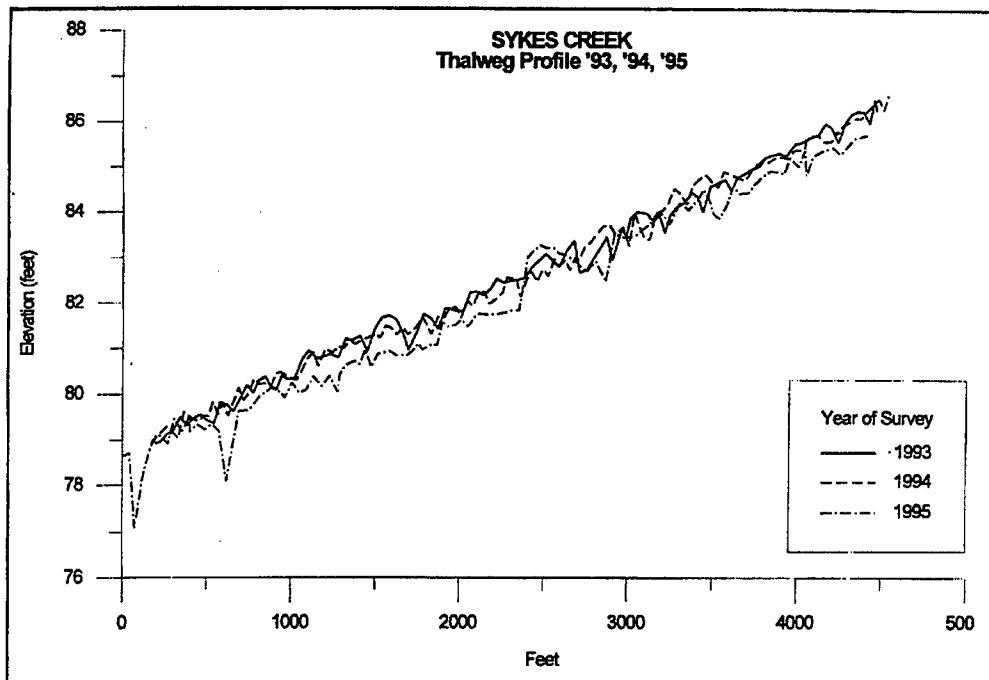
Figure 49. Thalweg profiles for Sykes Creek, site #17

The accompanying thalweg profile, shown in Figure 49, indicates that little change has occurred during the three year period, and by many indicators such as berm formation, depth of sand in the bed, and by thalweg comparison, the channel could be considered in quasi-equilibrium. However, comparison of the existing conditions to the slope and width required at minimum stream power for transport of 1000 mg/l indicates that the reach is transporting a high sediment load. The 1995, 2-year water surface slope is 211% of the minimum slope and the width is 71% of the width at minimum slope. In addition, BURBANK analysis indicates that approximately 40% of the channel banks are unstable if degradation occurs and the zero friction angle assumption is valid.
